**Report on conformance to the Global Industry
Standard on Tailings Management (GISTM)**

2023

Two Rivers Platinum Mine:
Old tailings storage facility 6

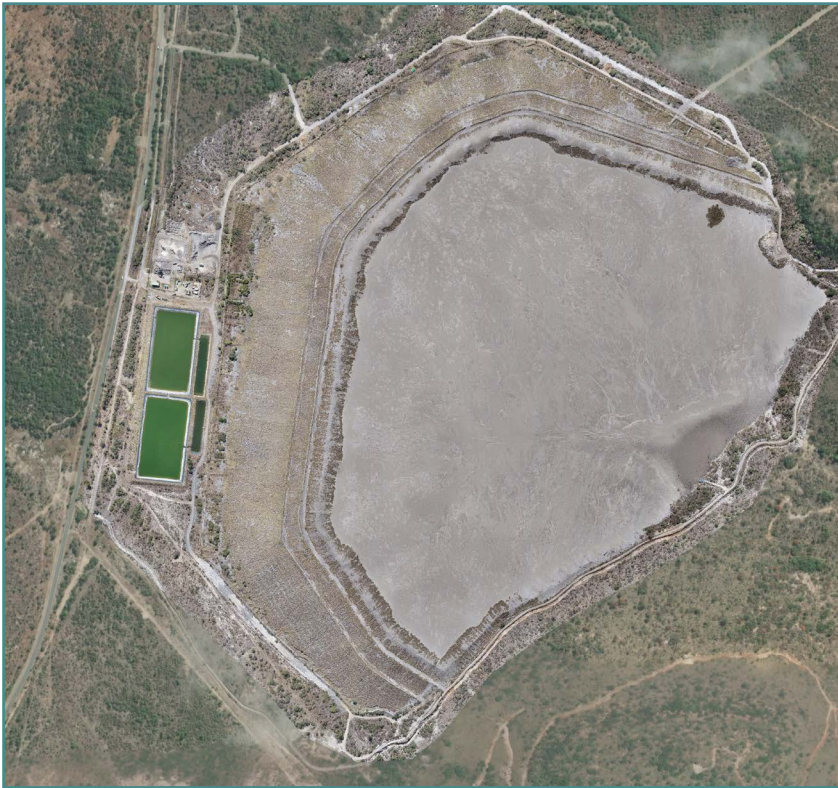
Figure 1-2: TRP tailings storage facilities locality map (Old TSF)

The Old TSF has been designed for a maximum safe final height of some 50m with an overall outer slope of 1V:3H. The facility was designed to accommodate a monthly production rate of 260 000 tonnes per month until March 2022 when deposition ceased. The TSF has a return-water dam (RWD) and a stormwater dam with a combined storage capacity of around 88 000m³.

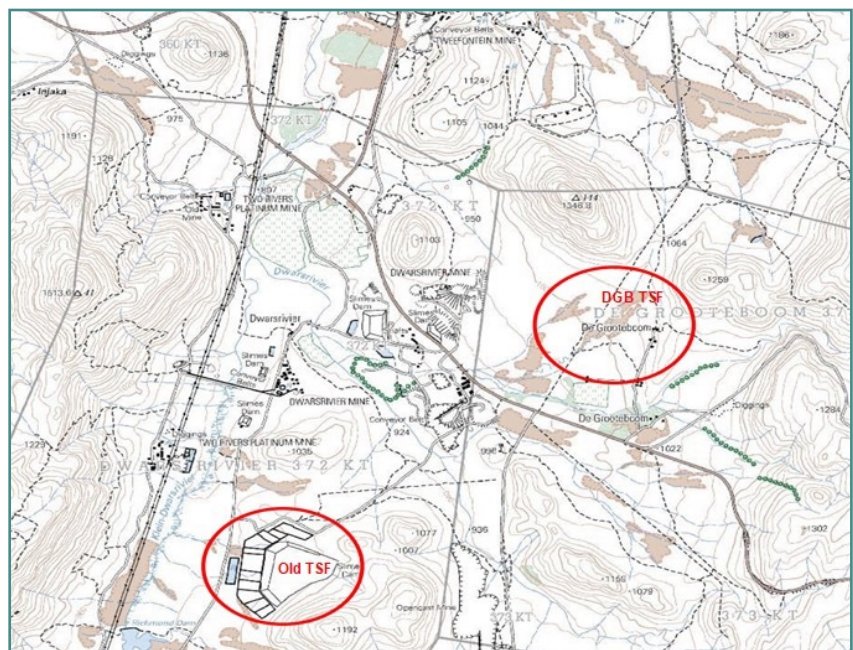
Figure 1-1: TRP tailings storage facilities locality map (De Grootboom and Old TSFs)

The De Grootboom TSF is situated on the farm Dwarsrivier on the southern part of the eastern limb of the Bushveld Complex, 45km south-west of Burgersfort, in the Limpopo province of South Africa, as illustrated in Figure 1-1.

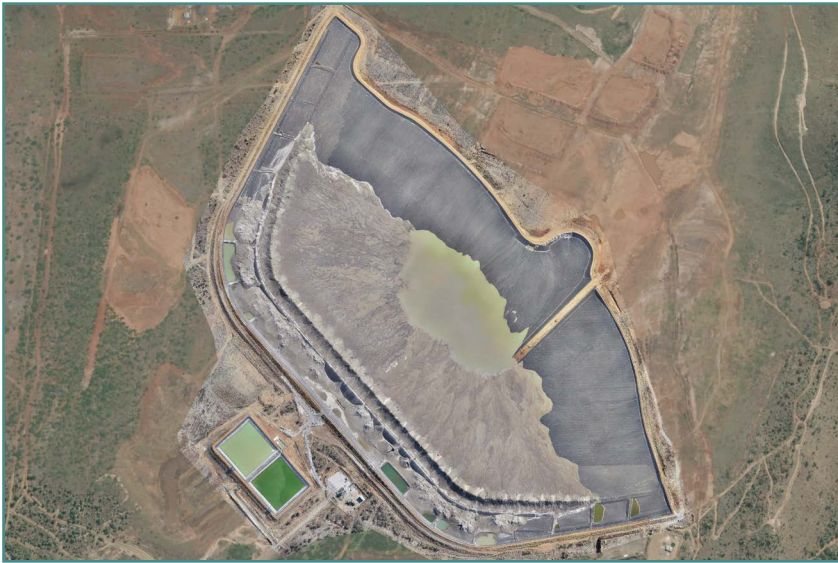
Figure 1-2: TRP tailings storage facilities locality map (De Grooteboom)

The TSF has been designed for a maximum final safe height of around 85m at 1 072mamsl elevation with an overall outer slope of 1V:3.5H. The design tailings deposition is 300 000 tonnes per month for the first two years and 500 000 tonnes per month from year 3. The return-water dam has a standby and an operating compartment with a total capacity of 98 000m³.

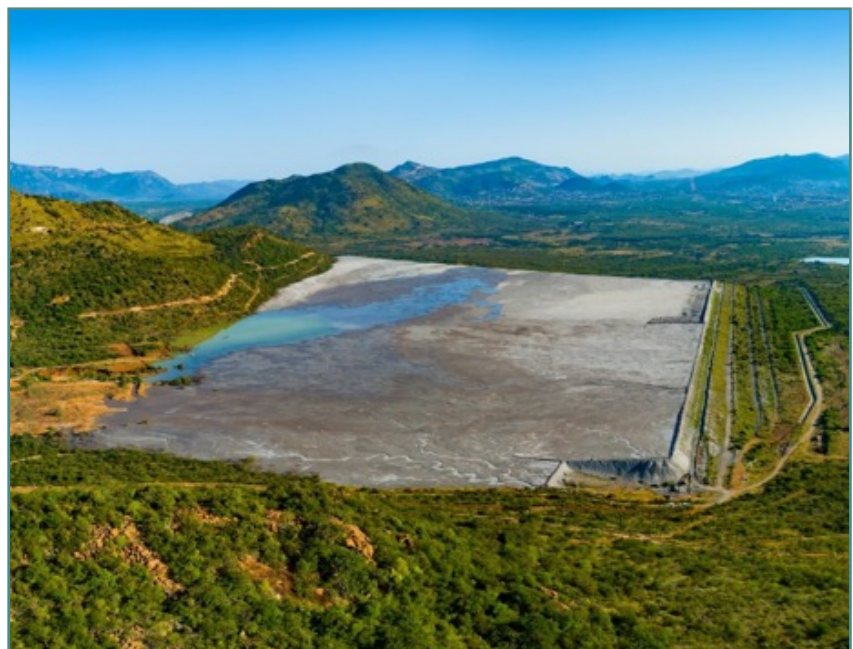
Figure 1-1: MPM tailings storage facility

MPM lies around 15km northwest of Burgersfort on the Polokwane-to-Burgersfort road (R37). The Modikwa tailings storage facility (Modikwa TSF) site is in a valley between the old Montrose and Winterveld chrome mines, some 3km east of the plant site (refer Figure 1-1). The Modikwa TSF is an upstream embankment facility with a life-of-mine of 50 years.

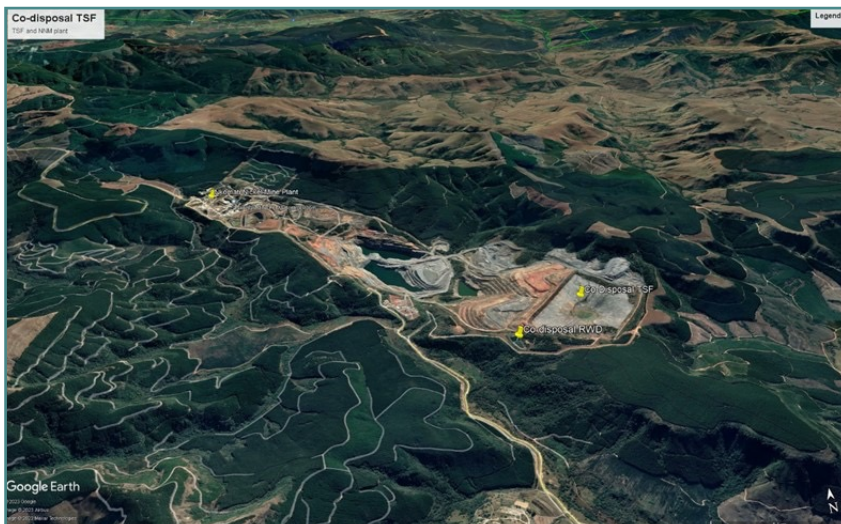
Figure 4-1: Topography local to the co-disposal TSF used for the dam break impact assessment

Results of the study have been used to inform the mine emergency preparedness and response plan (EPRP).

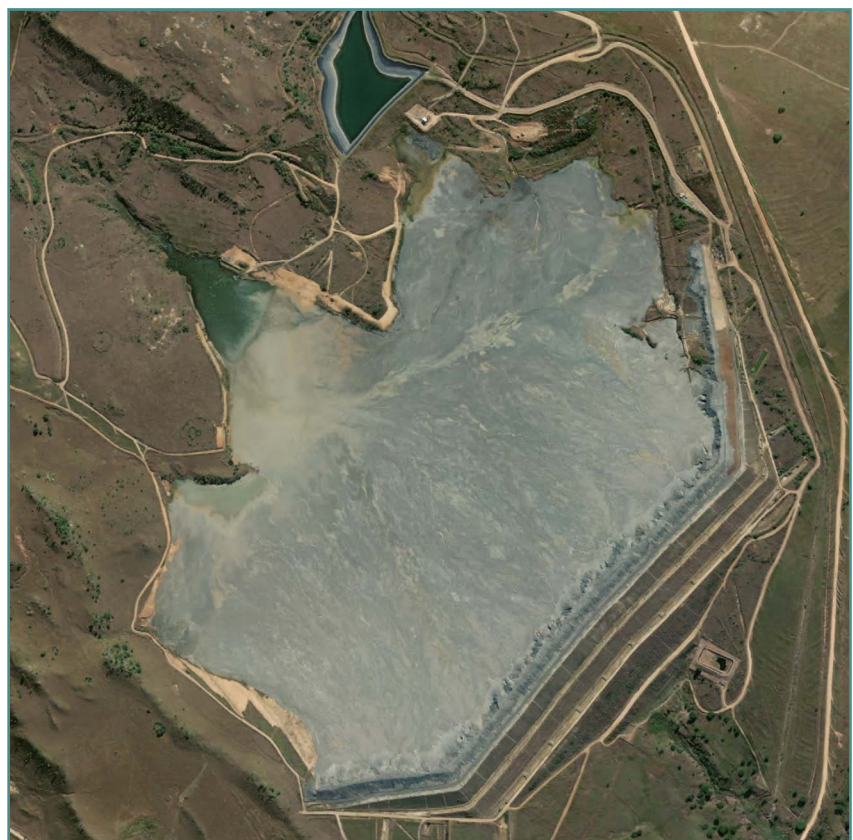
Figure 1-1: Onverwacht TSF

The facility is 14km south-east of the main mine site at 25°49'53.17"S and 30°38'39.99"E. The TSF was started in 2010 and is currently inactive.

The final design elevation for Onverwacht TSF is 1 180mamsl. Currently, the top of the containment wall is at an elevation of 1 165mamsl.
