2024 REPORT ON CONFORMANCE TO THE GLOBAL INDUSTRY STANDARD ON TAILINGS MANAGEMENT

Report on conformance to the  
Global Industry Standard on  
Tailings Management

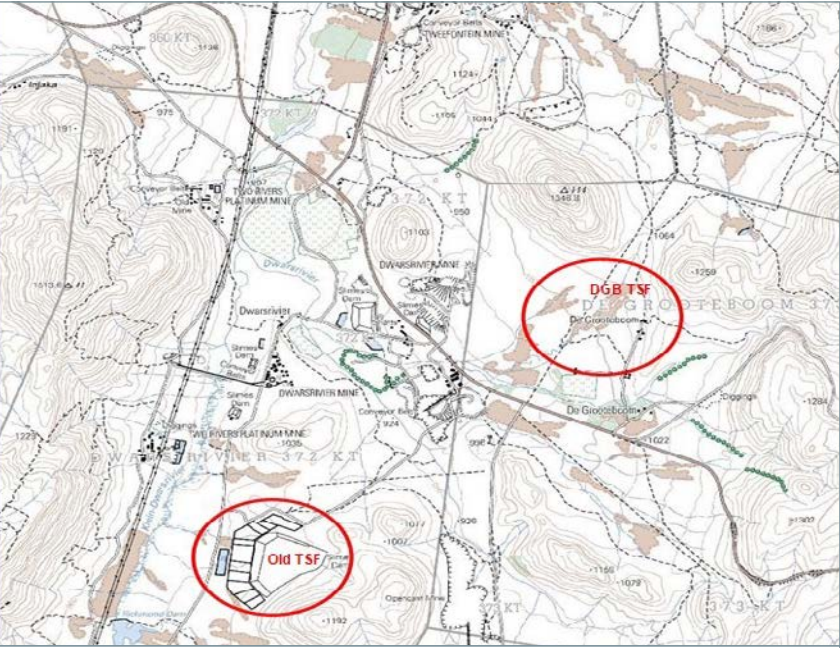
Figure 1-1: TRP tailings storage facilities locality map (De Grooteboom and Old TSFs)

Two Rivers Mine operates as a joint venture between Impala Platinum and African Rainbow Minerals (ARM) Platinum. It is situated on the farm Dwarsrivier in the southern part of the eastern limb of the Bushveld Complex, 45km south-west of Burgersfort, in Limpopo province of South Africa. The location of the Two Rivers Old TSF is illustrated in figure 1-1; this facility reached end of operational life in early 2022 and was simultaneously decommissioned.

The Old TSF has been designed for a maximum safe final height of some 50m with an overall outer slope of 1V:3H. The facility was designed to accommodate a tailings production rate of 300 000 tonnes per month until March 2022 when deposition ceased. The TSF has a return-water dam (RWD) and a stormwater dam with a combined storage capacity of around 88 000m³.

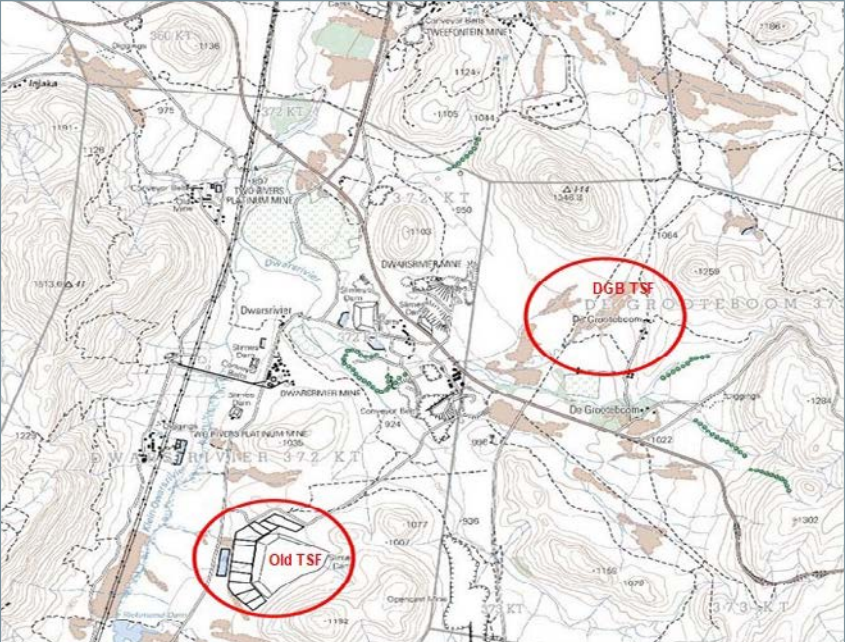
Figure 1-1: TRP tailings storage facilities locality map (De Grooteboom and Old TSFs)

The Two Rivers Platinum Mine is situated on the farm Dwarsrivier on the southern part of the eastern limb of the Bushveld Complex, 45km south-west of Burgersfort, in the Limpopo province of South Africa, as illustrated in figure 1-1.

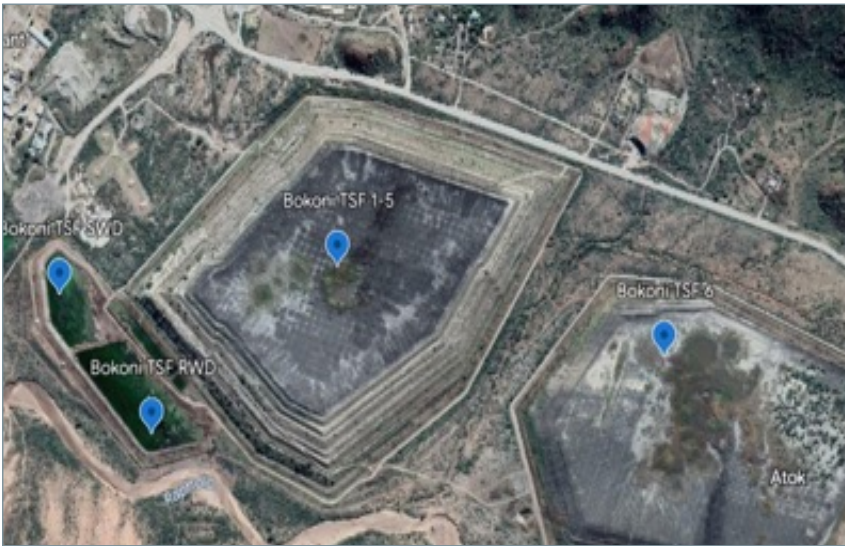
Figure 1: Bokoni Platinum Mine tailings storage facilities and plant

**Description of TSF 6**  
The Bokoni Platinum Mine is located some 80km from Polokwane on the Polokwane-Burgersfort road (R37). The TSFs and water dams are 500m east of the plant on the farms Middelpunt 420 KS and Umkoanestad 419 KS. The mine has two TSFs: Consolidated TSF 1-5 and TSF 6. The return-water dam (RWD) and stormwater dam (SWD) are adjacent to the TSFs, around 500m east of the concentrator plant. TSF 6 was recommissioned for operations in November 2023.

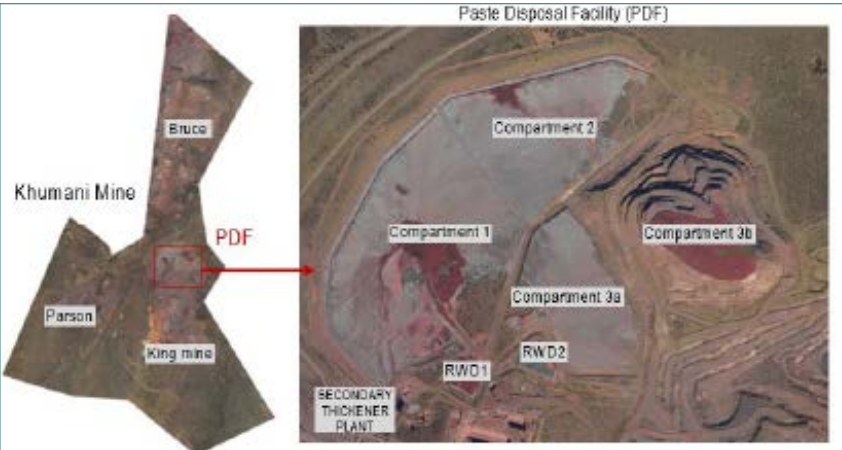
Figure 1-1: Khumani Mine paste disposal facility location and general layout

**Description of the Khumani Mine tailings storage facility**  
The Khumani Mine (KHM) does not have a traditional tailings storage facility. Tailings are first dewatered (through primary and secondary paste thickeners) to ensure that the material deposited onto the facility has a high percent of solids and low water content, hence the thickened tailings, paste-like consistency, and use of a paste disposal facility (PDF), which lies on the farm King to the north of the King Mine open-pit operations and 30km south of Kathu (refer figure 1-1).
