**Report on conformance  
to the Global Industry  
Standard on Tailings  
Management**

# Report on conformance to the Global Industry Standard on Tailings Management (GISTM)

# Introduction

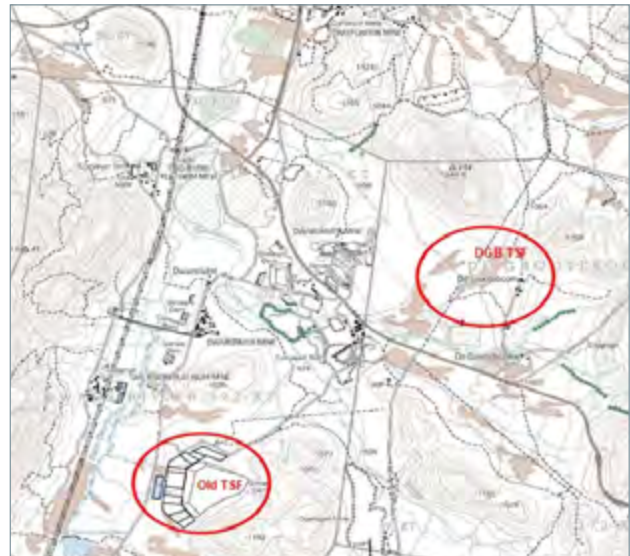
**Figure 1-1: Two Rivers Platinum TSF locality map (De Grootboom and Old TSFs)**

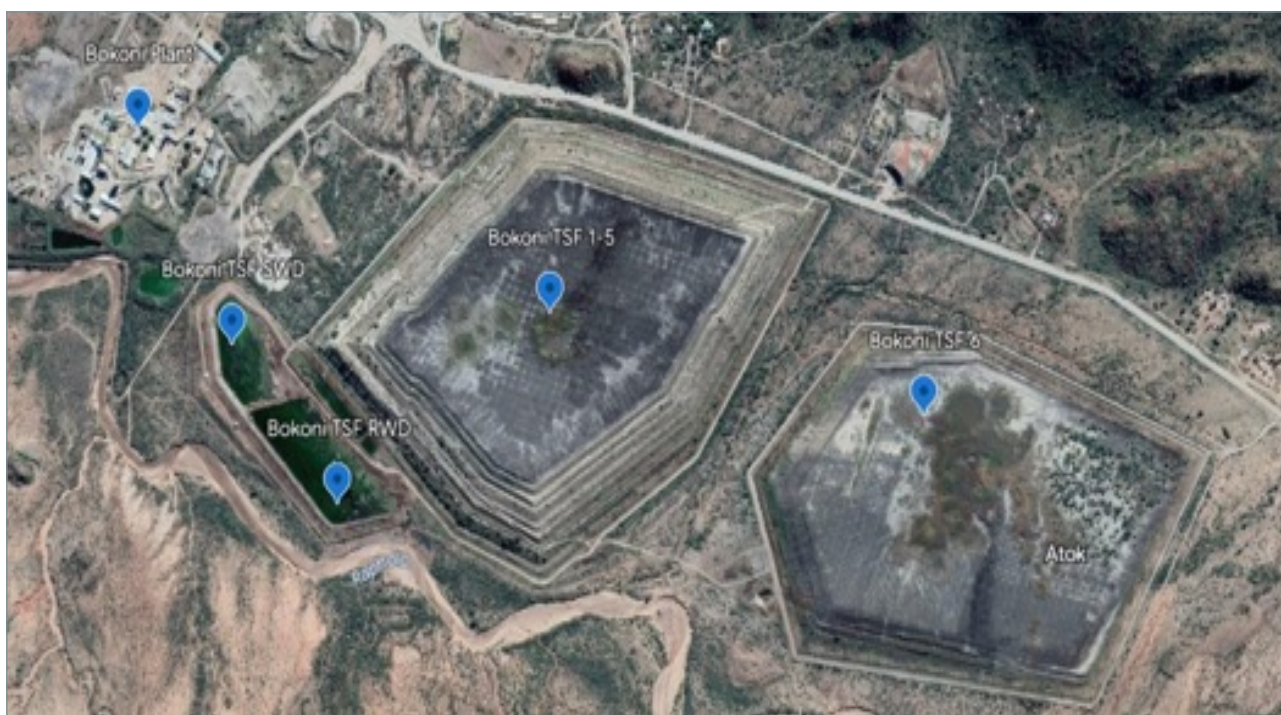
*Figure 1: Bokoni Platinum Mine tailings storage facilities and plant*

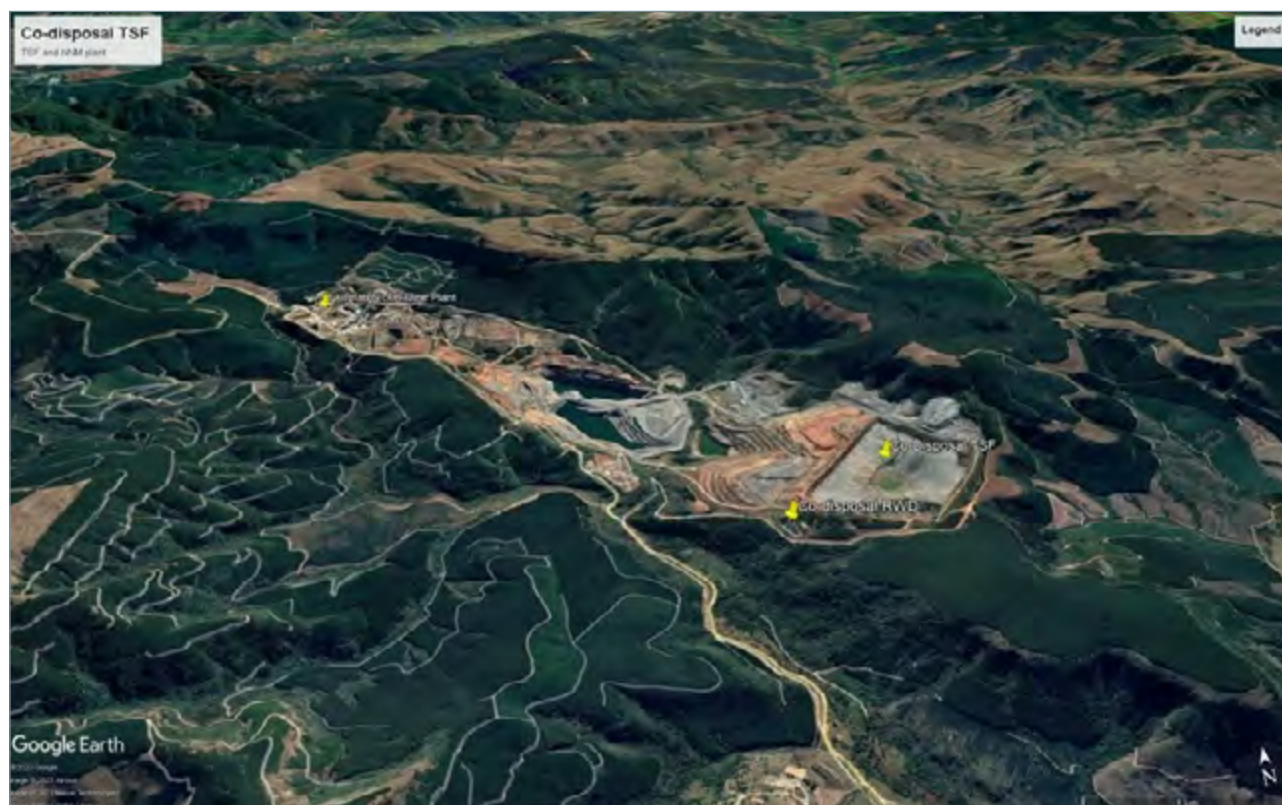
Figure 4-1: Topography local to the co-disposal TSF used for the dam break impact assessment

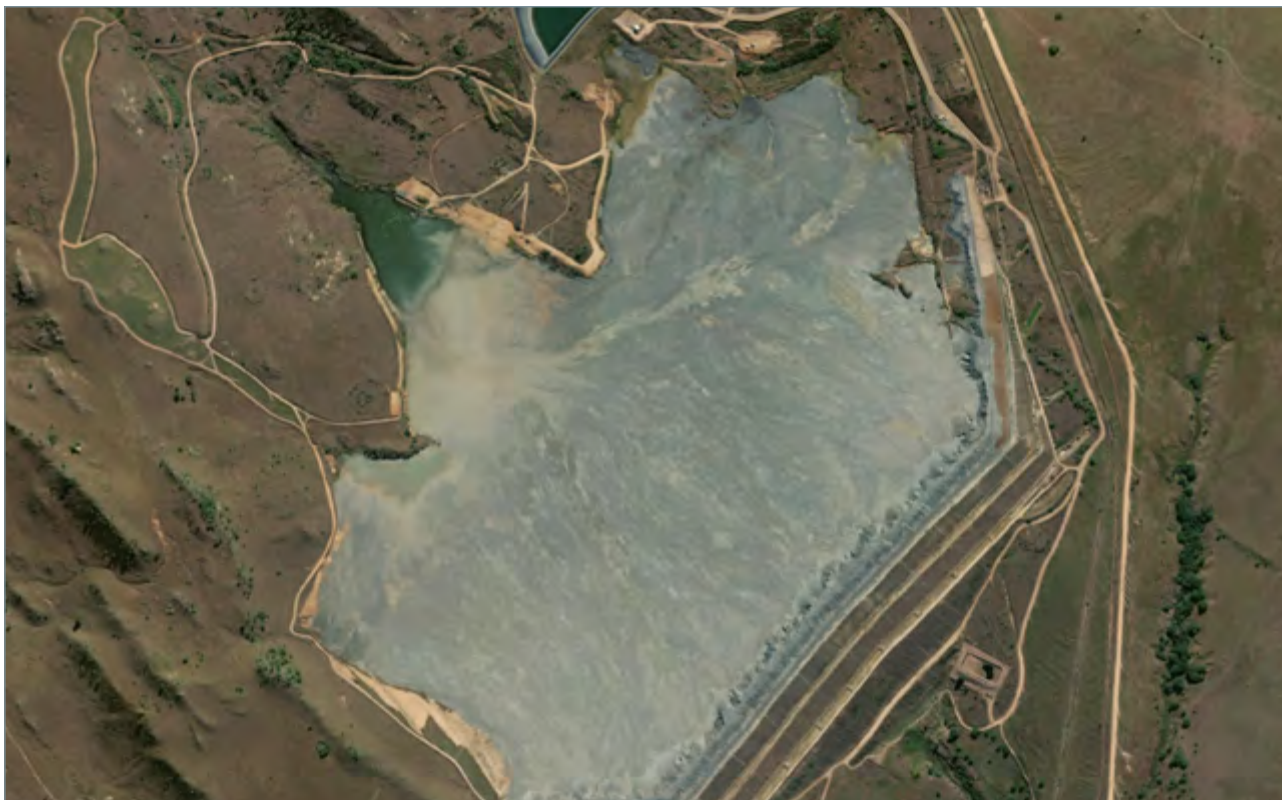
Figure 1-1: Onverwacht TSF

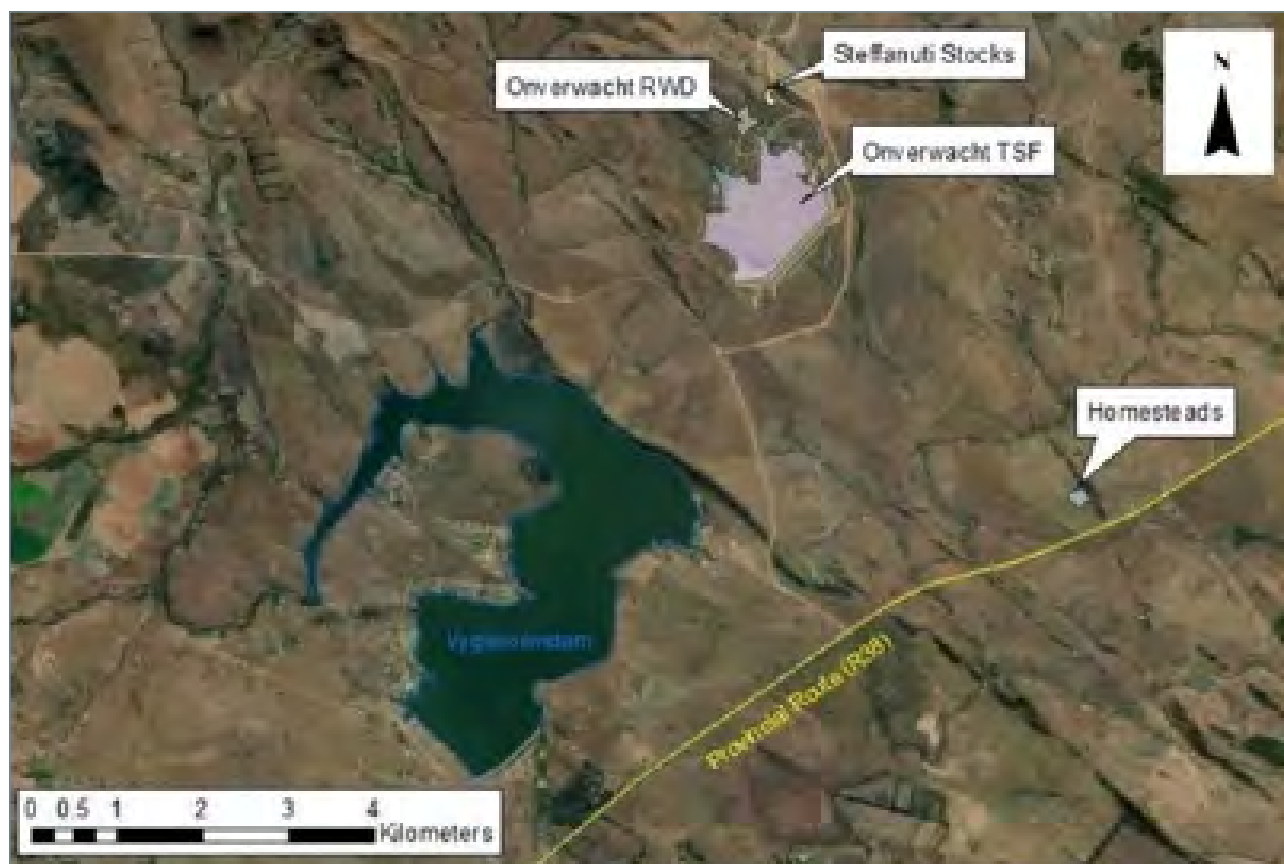
Figure 4-1: Onverwacht TSF areas of interest

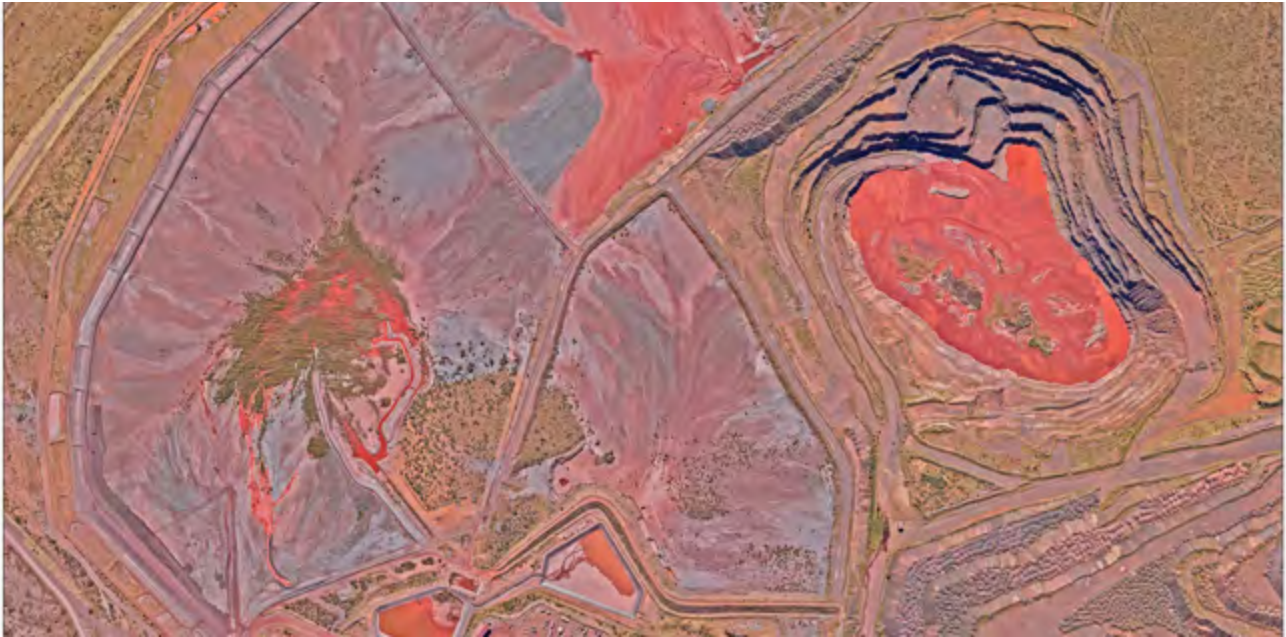
Figure 1-1: Khumani Mine paste disposal facility location and general layout

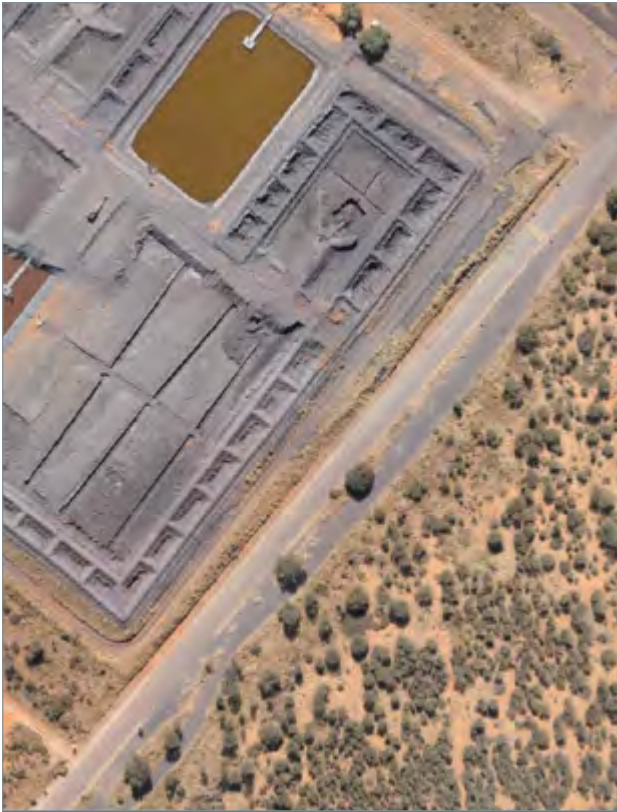
*Figure 1-1: Old Gloria tailings facility location and general layout*

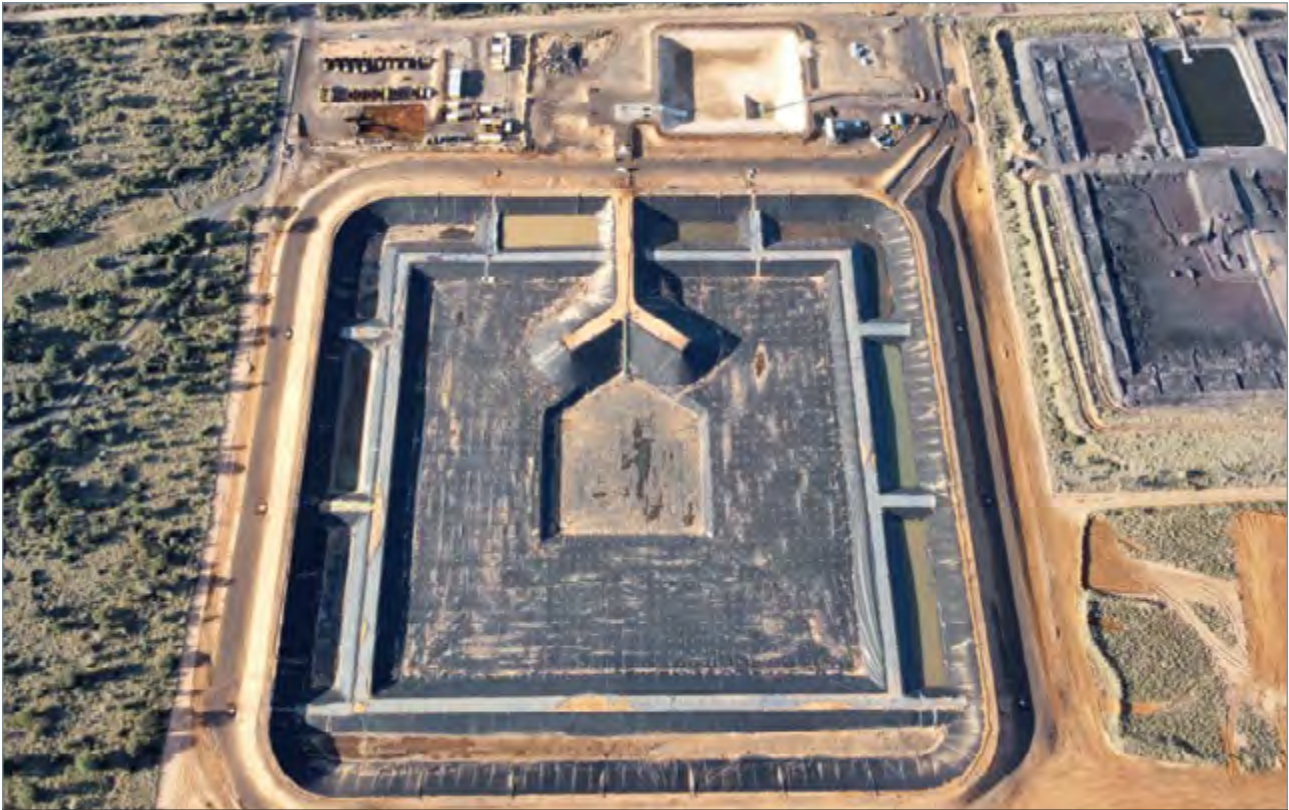
**Figure 1-1: Black Rock Mine Operations' new Gloria tailings disposal facilities location and general layout**

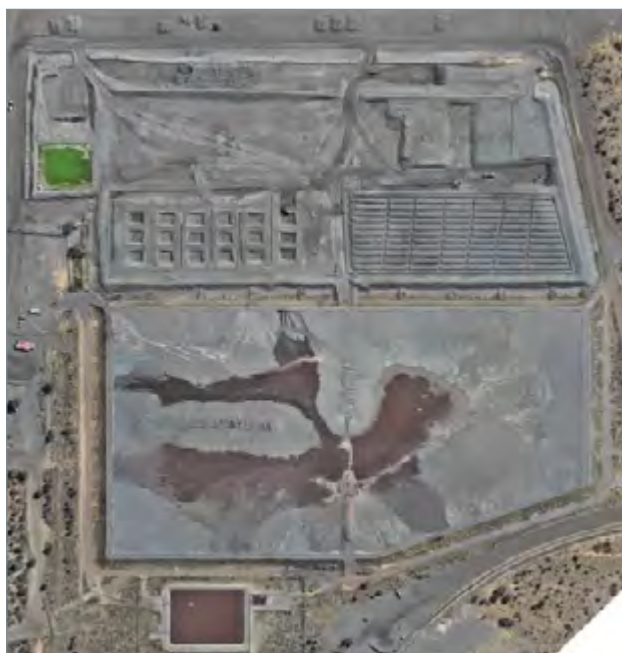
**Figure 1-1: Black Rock Mine Operations' Nchwaning 2 old facility location and general layout**

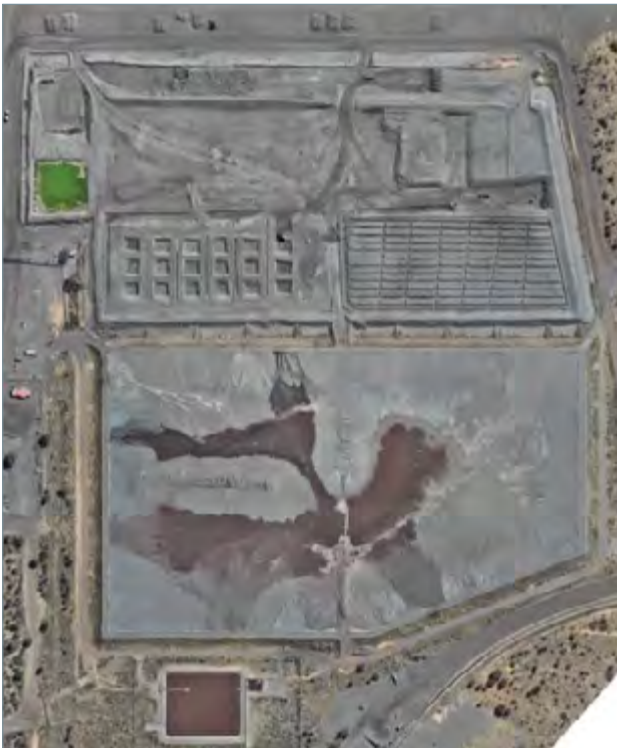
**Figure 1-1: Black Rock Mine Operations' tailings disposal facilities location and general layout**
